## Culvert Replacement

# Larry and Cindy Johnson

## Trillium Stables Agricultural Water Quality Project

### Trillium Stables Agricultural Drainage Management Plan

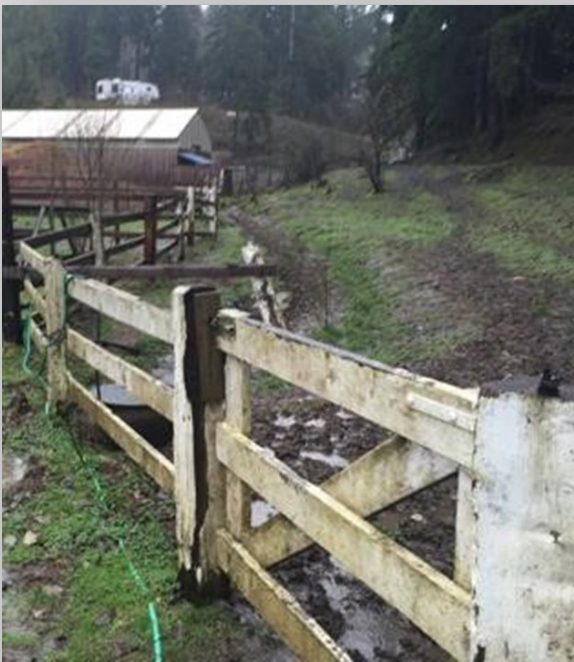
*(Below) Initial site visit, December 2015 shows original condition of the small hillside pasture which was being used as an exercise area, and tributary stream.*

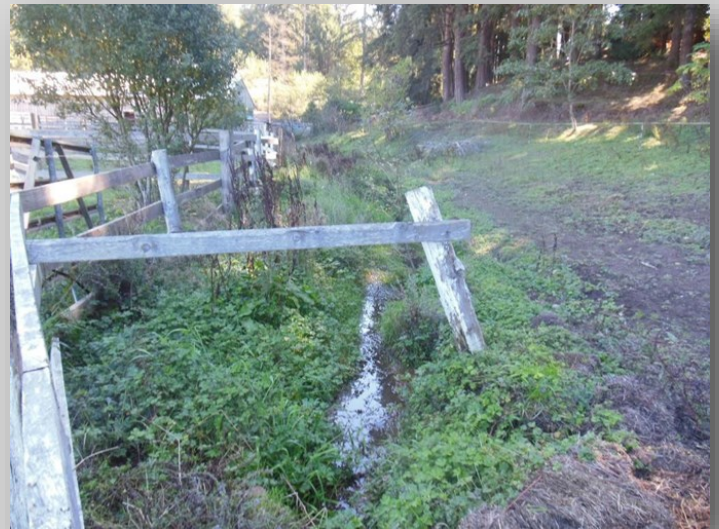
*(Above) Follow-up site visit, October 3<sup>rd</sup> 2017 shows improved condition of the small hillside pasture (now retired) which was being used as an exercise area, and vegetation beginning to grow up along tributary stream.*

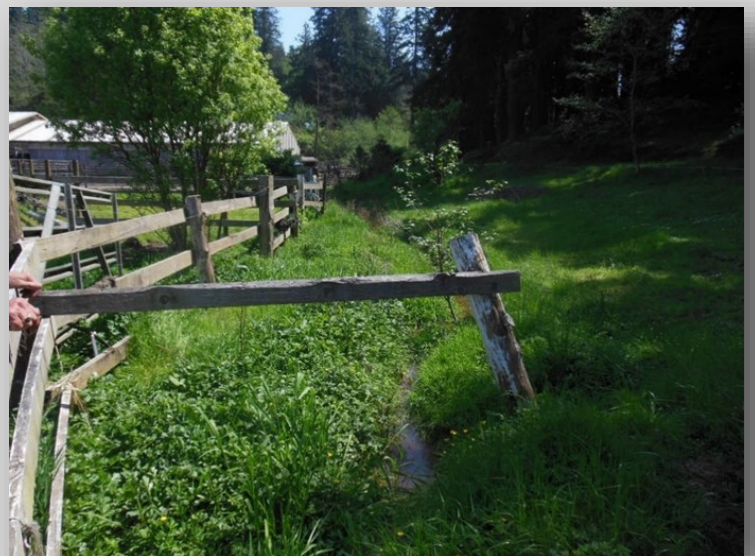
*(Right) follow-up site visit, April 25th 2018 shows improved condition of the small hillside pasture (now retired) which was being used as an exercise area, and vegetation grown up along tributary stream.*

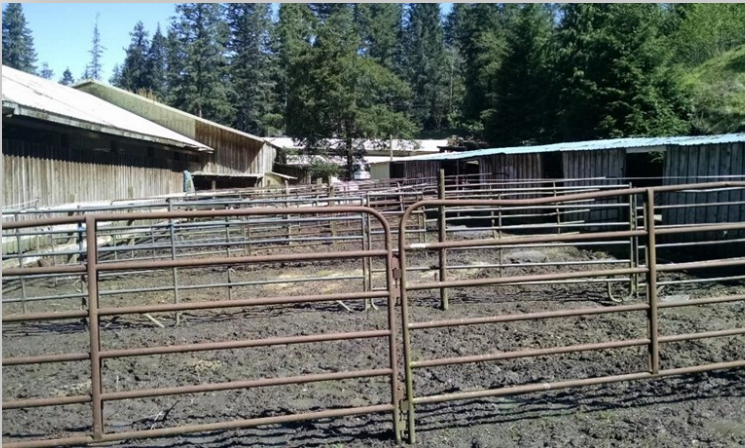
BEFORE

Paddocks between barn and stables. BEFORE: Highly concentrated mud/manure runoff area (6- 14-2017)

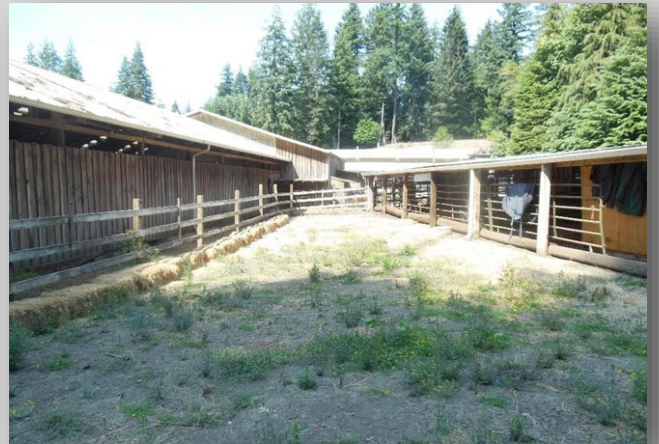
AFTER

Paddocks between barn and stables. AFTER: Paddocks have been reduced and covered with roofing. Sparsely grassed area in the center is to be used as a buffer. Vegetation has been slow to grow due to compaction and poultry eating the grass seeds (8-8-2018).

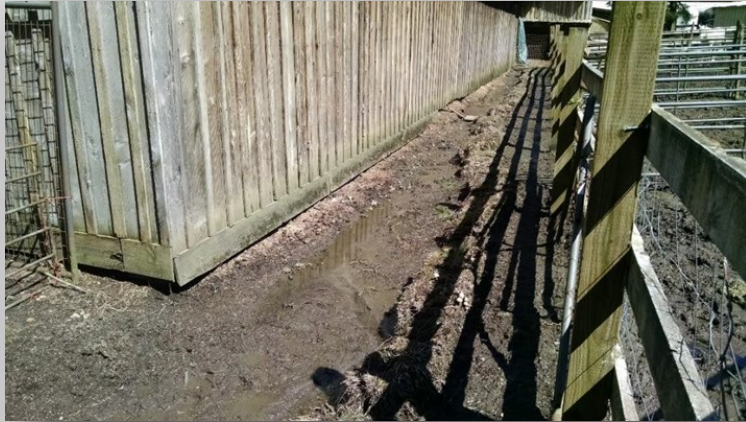
Main Barn, adjacent drainage: BEFORE (6-14-2017)

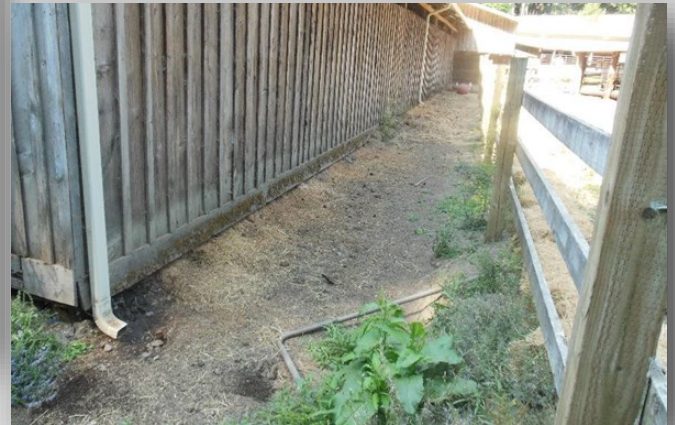
Main Barn, adjacent drainage: AFTER (8-8-2018)

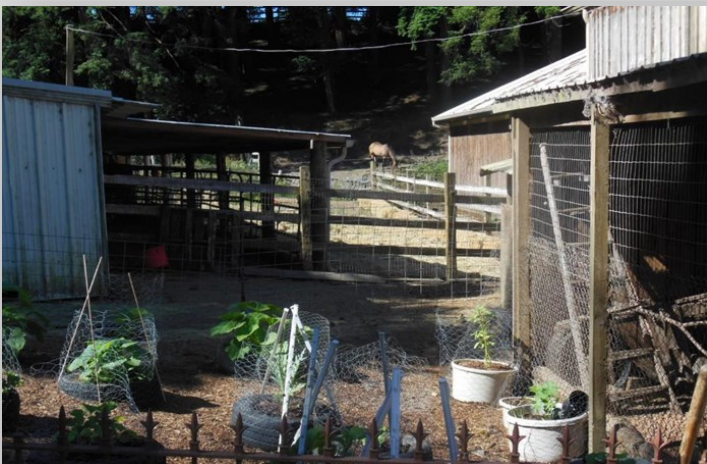
Main Barn, adjacent drainage (facing south). AFTER: Culvert has been installed so that there is no longer any above-ground flow through the stable yard; tree removed and vegetable garden planted (7-3-2018).

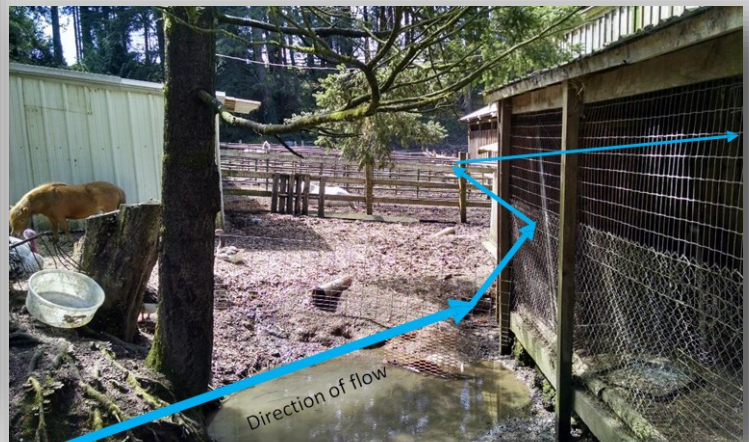
BEFORE water flows directly through the stable yard and alongside main barn (6-14-2017)

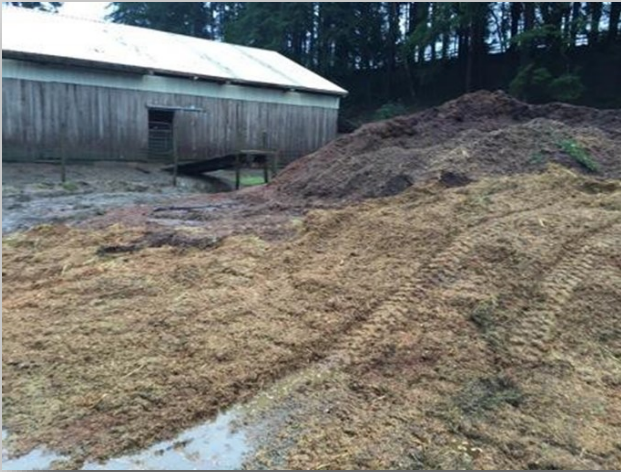
BEFORE

Initial site visit, December 2015. Original location of manure pile.

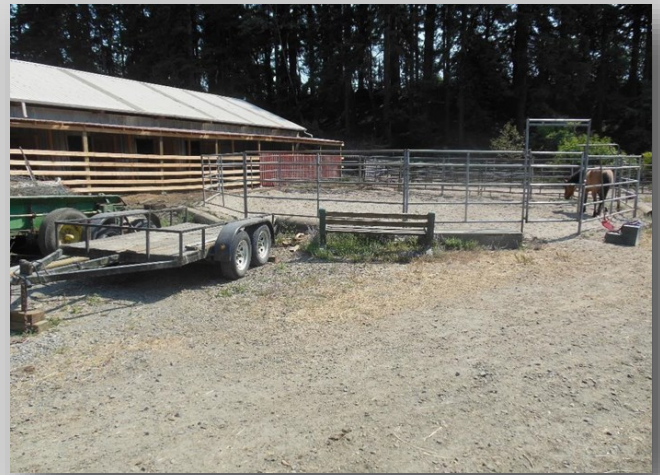
AFTER

Final site visit, August 2018. Original location of manure pile (now an exercise area)

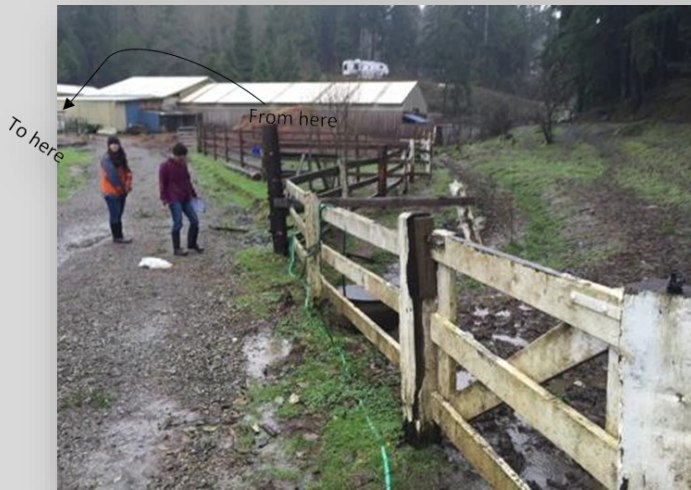
Initial site visit, December 2015. Original location of manure pile.

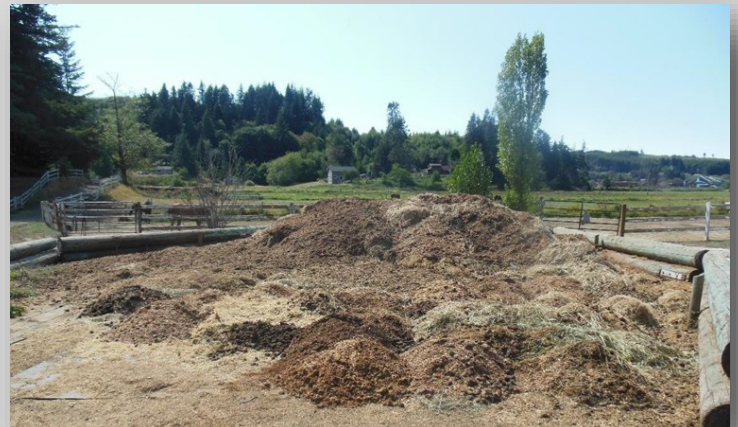
FINAL site visit, August 2018. New location of winter-storage manure pile, on a hardened gravel surface overlaid with rubber stall mats, and with telephone pole curbs to further prevent any runoff in direction of stream.

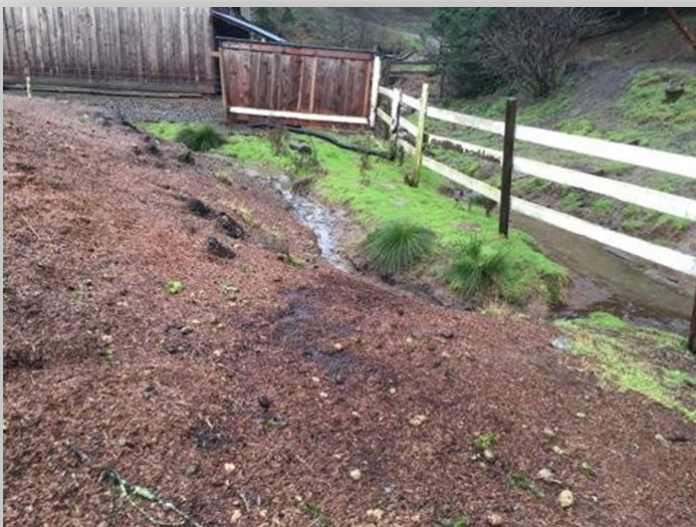
Initial site visit, December 2015 shows highly concentrated manure- runoff flowing directly into the tributary stream

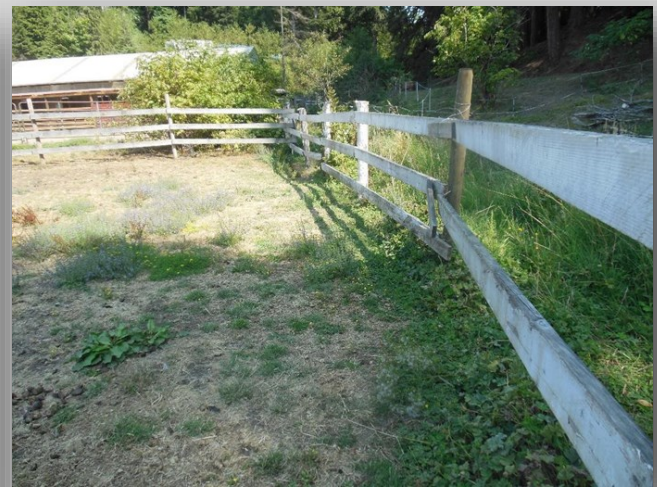
FINAL site visit, August 8<sup>th</sup> 2018 shows improved condition of the corral area; the pile has been relocated; gutters and roofing have been constructed on the west side of the barn to prevent runoff from the stalls on that side. A vegetative buffer has been established along the tributary stream.
