2018 Cooperators of the year AWARD:

Trillium Stables Agricultural Water Quality Project

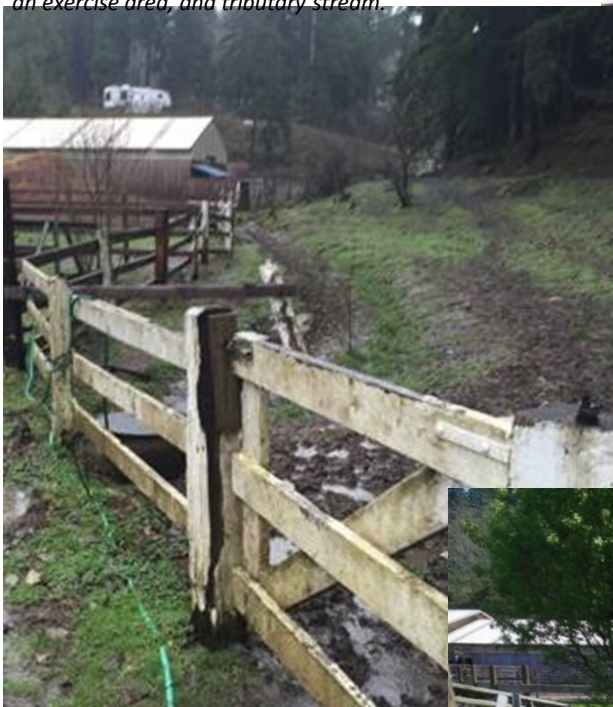
(Below) Initial site visit, December 2015 shows original condition of the small hillside pasture which was being used as an exercise area, and tributary stream.

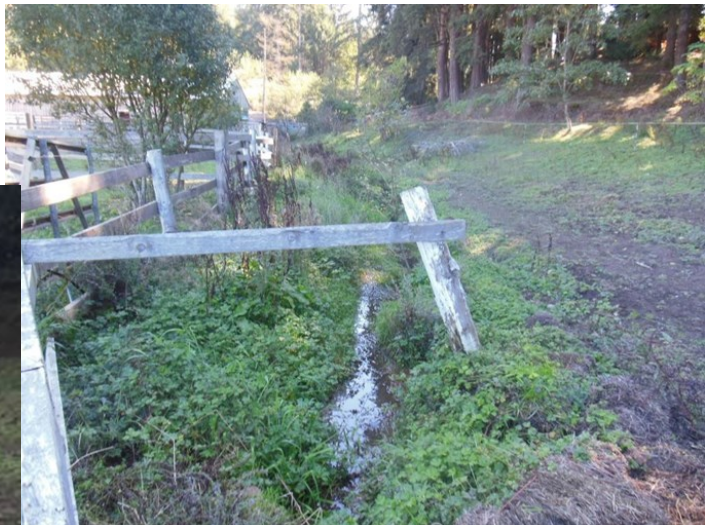
(Above) Follow-up site visit, October 3rd 2017 shows improved condition of the small hillside pasture (now retired) which was being used as an exercise area, and vegetation beginning to grow up along tributary stream.

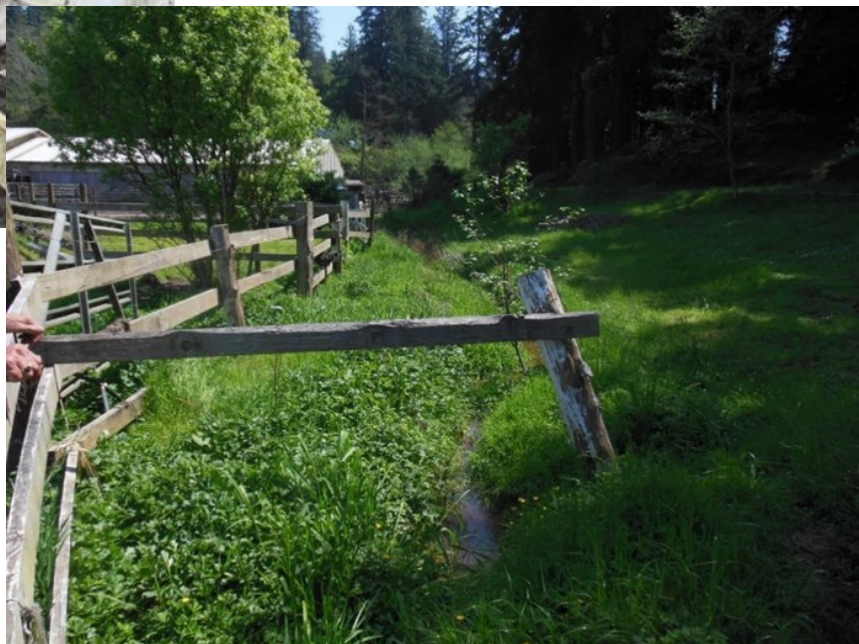
(Right) follow-up site visit, April 25th 2018 shows improved condition of the small hillside pasture (now retired) which was being used as an exercise area, and vegetation grown up along tributary stream.

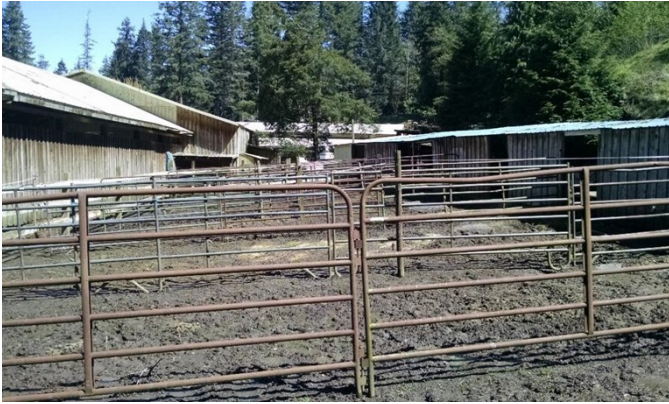
BEFORE

Paddocks between barn and stables. BEFORE: Highly concen-

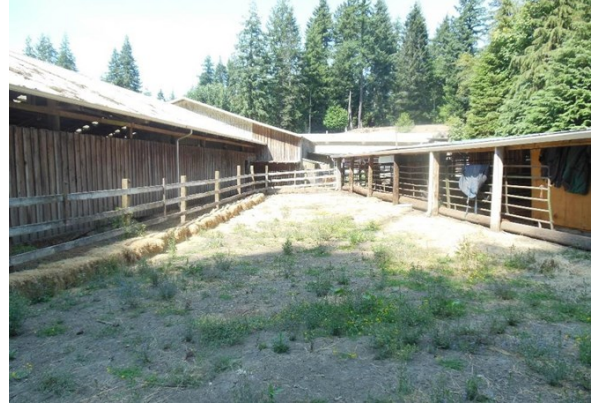
AFTER

Paddocks between barn and stables. AFTER: Paddocks have been reduced and covered with roofing. Sparsely grassed area in the center is to be used as a buffer. Vegetation has been slow to grow due to

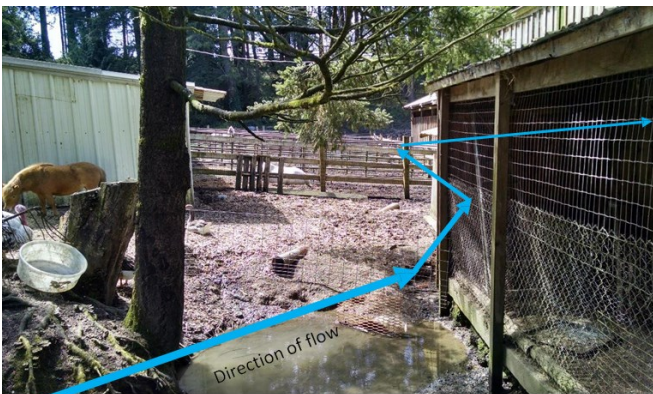
BEFORE water flows directly through the stable yard and alongside main barn (6-14-2017)

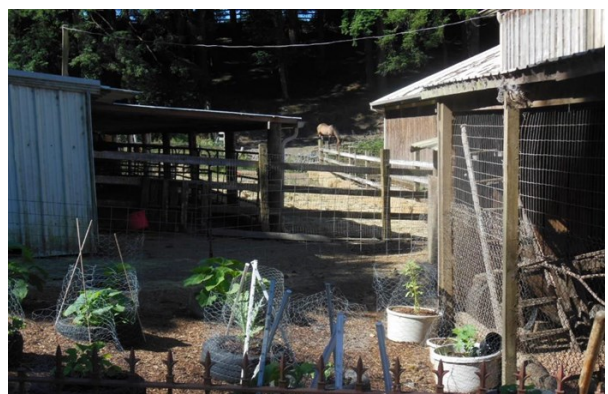
Main Barn, adjacent drainage (facing south). AFTER: Culvert has been installed so that there is no longer any above-ground flow through the stable yard; tree removed and vegetable garden planted (7-3-2018).

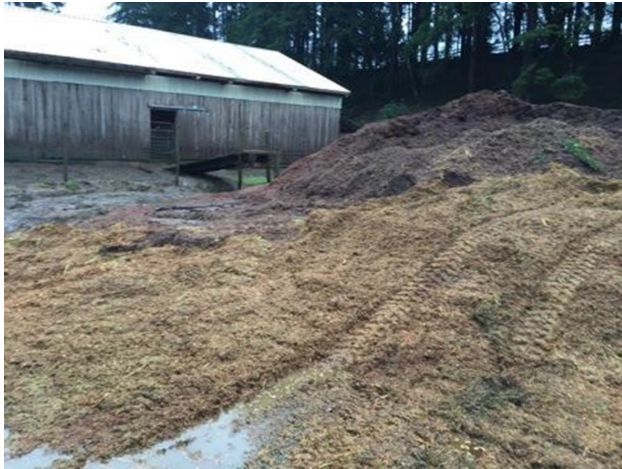
Initial site visit, December 2015. Original location of manure pile.

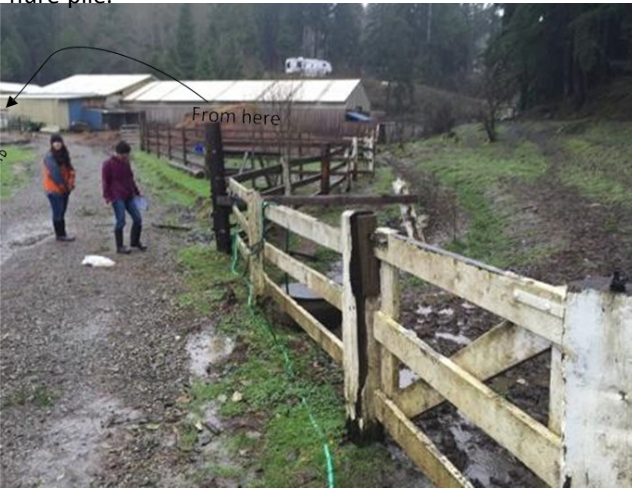
Initial site visit, December 2015. Original location of manure pile.

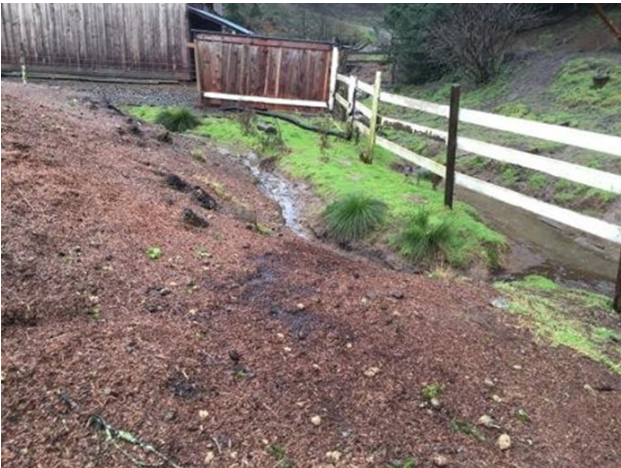
Initial site visit, December 2015 shows highly concentrated manure- runoff flowing directly into the tributary

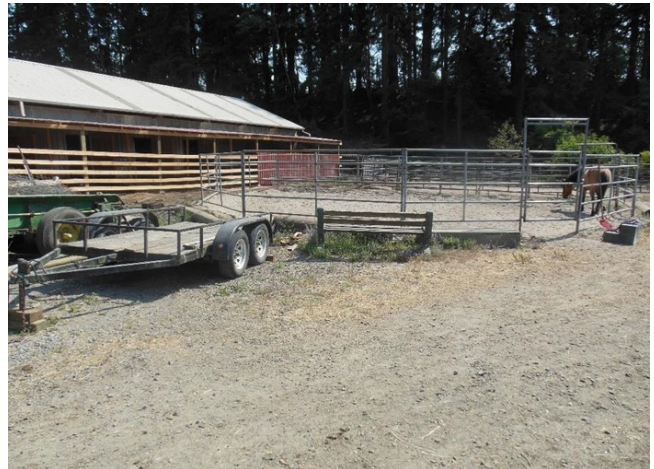
Final site visit, August 2018. Original location of manure pile (now an exercise area)

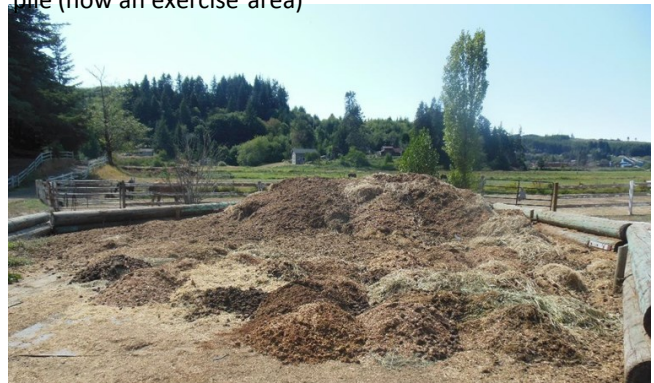
FINAL site visit, August 2018. New location of winter-storage manure pile, on a hardened gravel surface overlaid with rubber stall mats, and with telephone pole curbs to further prevent any runoff in direction of stream.

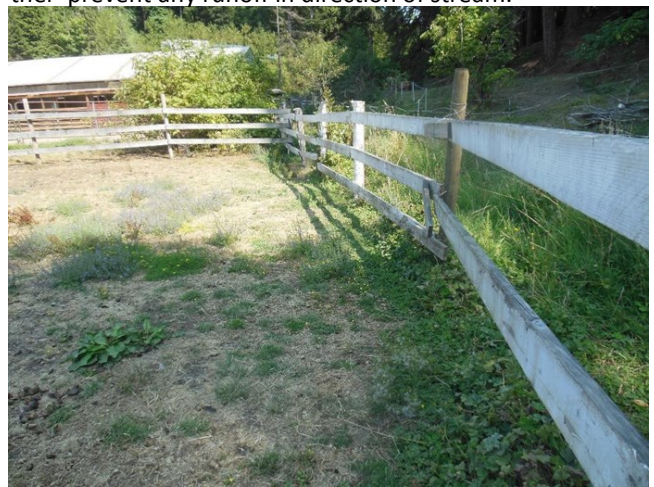
FINAL site visit, August 8th 2018 shows improved condition of the corral area; the pile has been relocated; gutters and roofing have been constructed on the west side of the barn to prevent runoff from the stalls on that side. A vegetative buffer has been established along the tributary stream.
