Lower Coquille Strategic Implementation Area (SIA) Water Quality Monitoring Summary and Update

By Andrew Chione, Water Quality Program Manager, Coos SWCD

October 2021

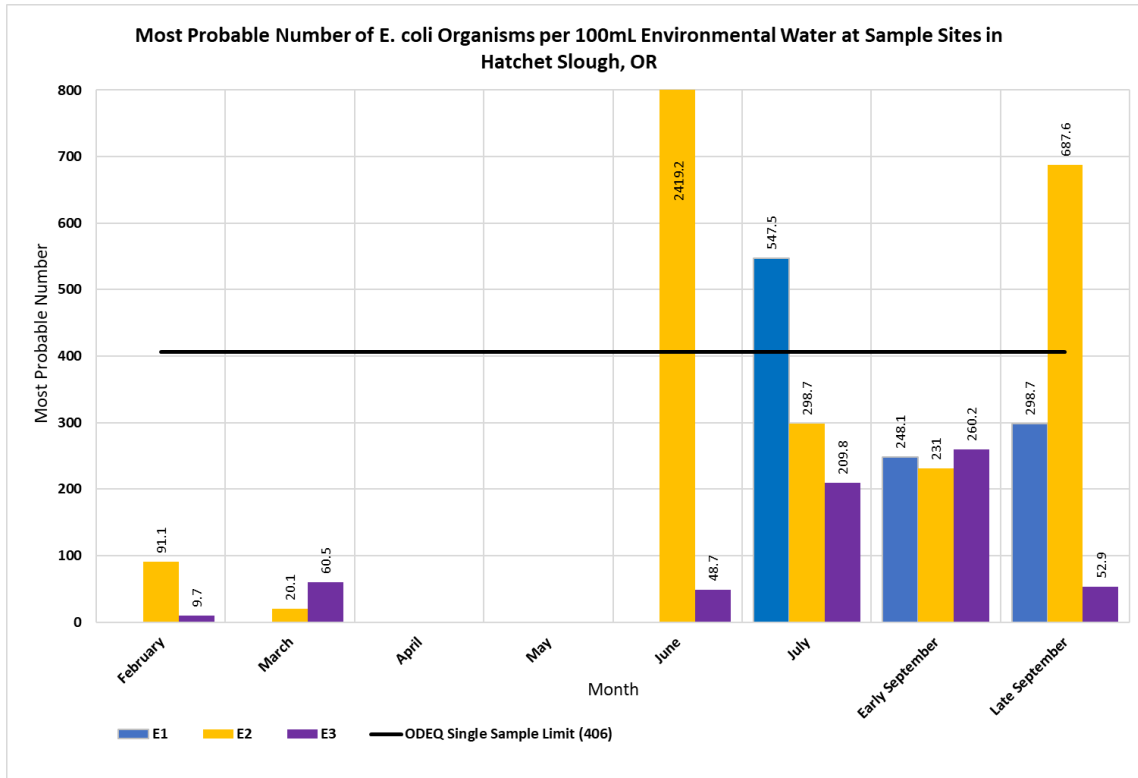
Figure 3. Results from *E. coli* monitoring on Hatchet Slough during 2021

During spring 2021, all E. coli concentrations measured were lower than the ODEQ single sample standard of 406 E. coli organisms per 100mL sample water. Concentrations during summer 2021 were higher than in spring, with several samples exceeding the ODEQ single sample standard (see Figures 3-5). Four sites at Bear Creek (E7, E11, E12 A, and E12 B) and two sites at Hatchet Slough (E1 and E2) exceeded the single sample standard at least once so far during 2021. No sites at Lampa Creek have exceeded the single sample standard so far.

During June 2021, two sites (E2 on Hatchet Slough and E12A on Bear Creek) measured extraordinarily high *E. coli* concentrations of 2419.2 and 1732.9 organisms per 100mL of water, respectively (see Figures 3 & 5). Duplicate QA samples were subsequently collected at site E2 (Hatchet Slough) during September. This was done to test sampling precision at that site in case high measurements were recorded again. All E. coli duplicate samples analyzed so far in 2021 were close enough to the original samples to qualify as “A” level data by ODEQ (see Figure 6). For duplicate samples to qualify as “A” level data, the difference between the log of the standard sample and the log of the duplicate sample at a site must be ≤ 0.6 log units.

E. coli concentrations between different sites varied widely from June through September, even between sites on the same stream. Concentrations were more similar to other sites in the same stream during the early spring (see Figures 3-5). This may suggest that localized conditions affect *E. coli* concentration in project area streams during low flows in the summer and early fall. Individually, most sites exhibited a trend of higher *E. coli* concentrations from June through September. All exceedances of

the ODEQ single sample limit (two sites in Hatchet Slough and four sites in Bear Creek) occurred during this time period (see Figures 3-5). This supports the hypothesis that *E. coli* concentration is higher in the summer and early fall. Cattle spend more time in stream channels drinking and cooling off and in riparian areas grazing during this time period. Flows in all three study streams were very low from June through September. Some Pools in Bear Creek were even observed to be separated by dry riffles. Because water quantity was low during this time period, the study sites could have been more susceptible to high *E. coli* concentrations.

When comparing streams, Bear Creek and Hatchet Slough appear to be more impacted by *E. coli* pollution than Lampa Creek (see Figures 3-5). Livestock have access to the stream channel at, or just upstream of, all three monitoring sites on Hatchet Slough and at all but one site on Bear Creek. There is no livestock access to the stream channel at the properties with monitoring sites on Lampa Creek. The Lampa Creek properties also seem to have fewer livestock grazing than properties on Bear Creek and Hatchet Slough, so this could explain the lower *E. coli* measurements. If this trend continues, Bear Creek and Hatchet Slough should be prioritized for restorative actions. However, Lampa Creek would still benefit from riparian planting and fencing to increase riparian shade and prevent future livestock access to the stream channel.

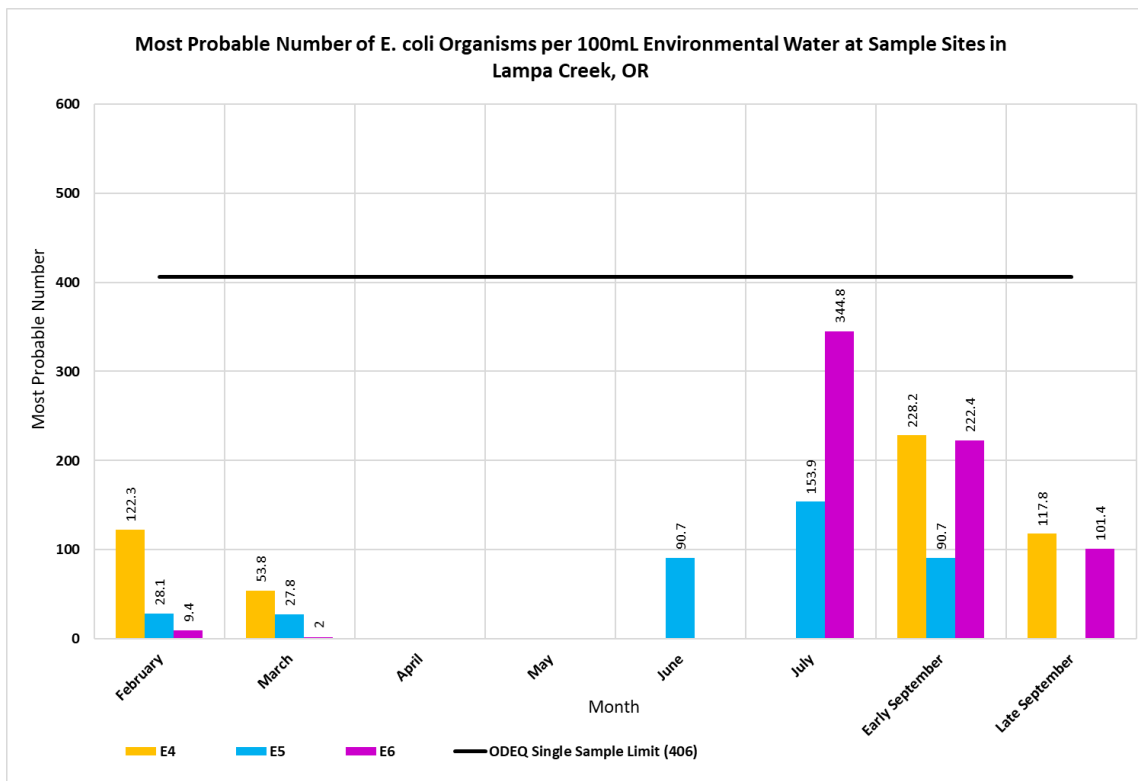
Figure 4. Results from *E. coli* monitoring on Lampa Creek during 2021

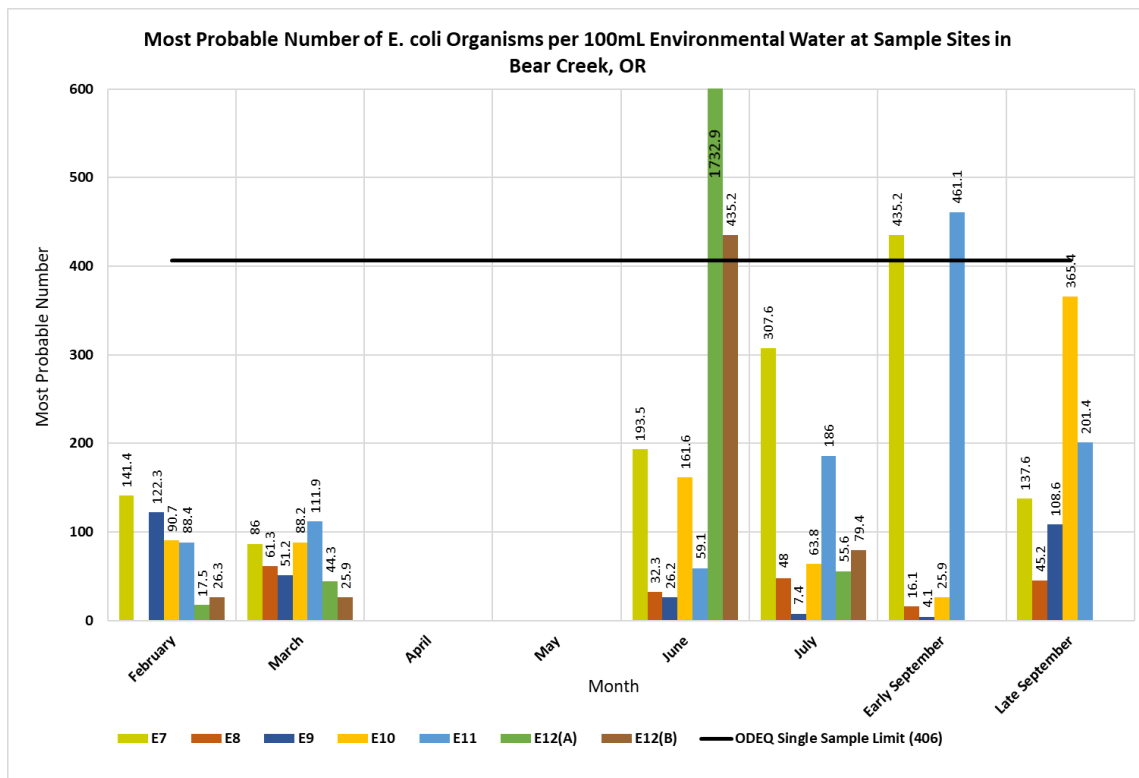
Figure 5. Results from *E. coli* monitoring on Bear Creek during 2021
