Winter Lake Phase III Project *Hydrologic Assessment*

January, 2022

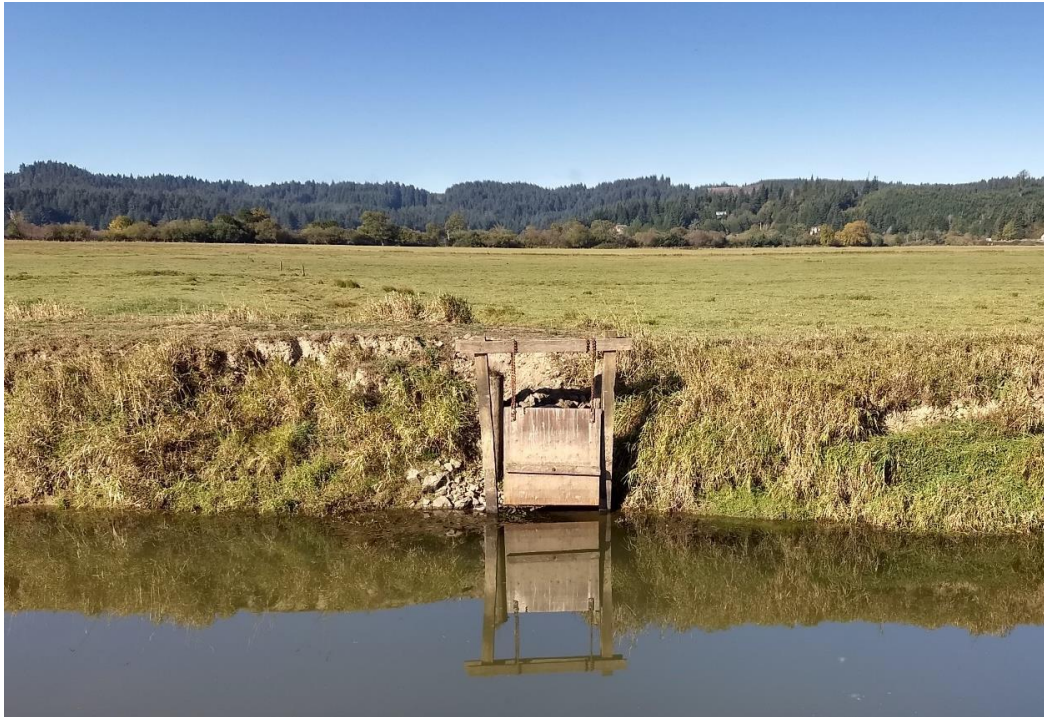
Figure 4. Typical top hinged flapper tidegate style currently used within Units 1 and 3.

Top-hinged tidegates on the existing interior culverts upstream of the C3P tidegates that are difficult to manage in the open position (Figure 4). This results in restriction of fish movements from the canals into pasture floodplain channels where food availability is higher and competition with non-native fish lower.

tidegates predominate currently (*Figure 4*). These will be replaced with either slide style vertical knife gate water control devices or side-hinged aluminum tidegates with a device to maintain the door open as desired. The BSDD DWMP dictates the water management strategies (Appendix A). This DWMP provides for a high degree of access for water and fish from the mainstem Coquille River during winter months. Landowners are on board with managing interior pasture channel culvert water control structures from November 1 to March 30th in alignment with the BSDD DWMP and needs for fish access and floodflow hydrology.

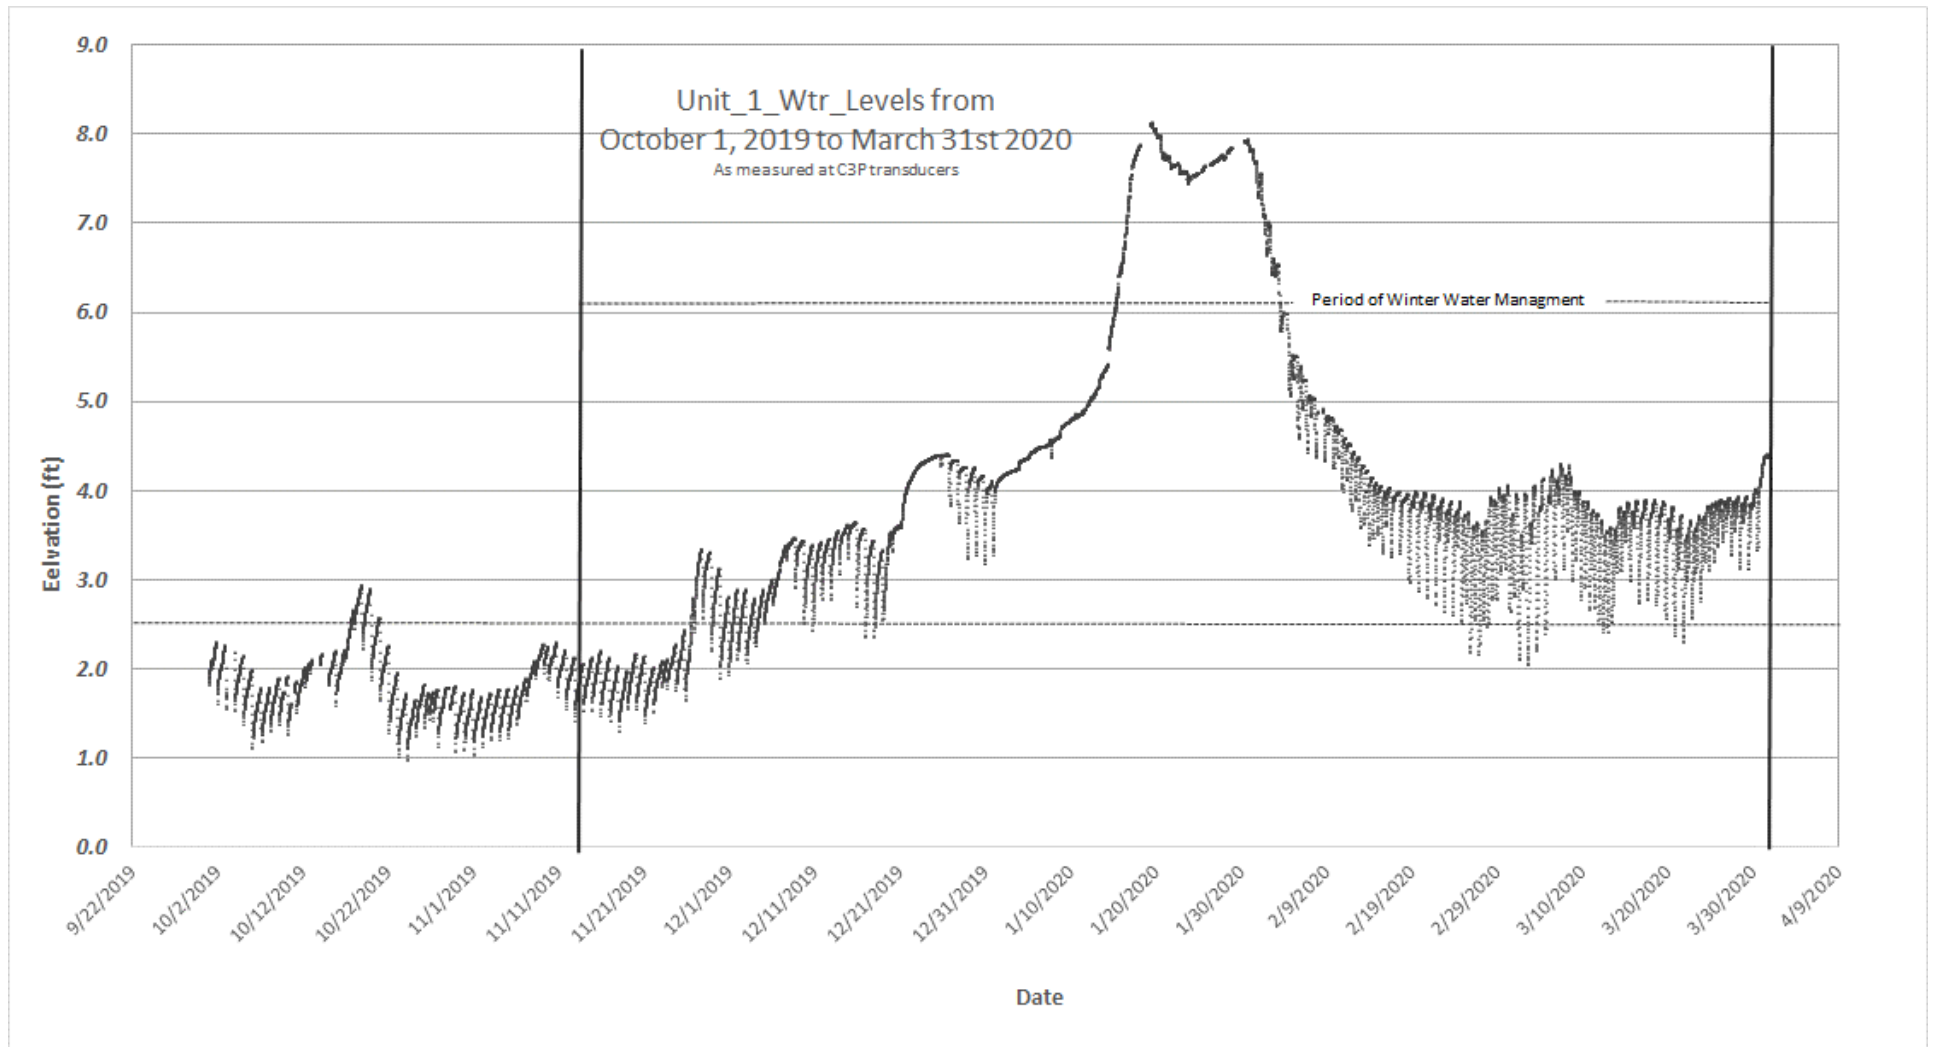
Figure 16. Unit 1 water levels from October 1, 2019 to March 31st, 2020 as measured at upstream of the C3P tidegates in Unit 1 canal.

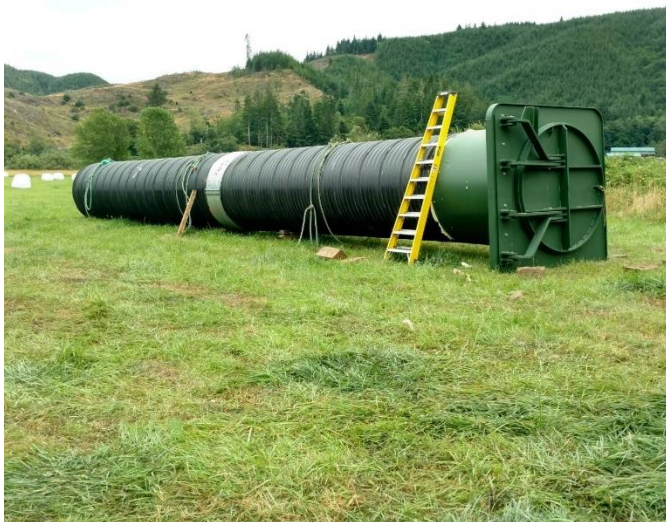
Figure 3. Typical side-hinged aluminum tidegate mounted on 6.0ft CMP.
